Service Information

Issued by
Nuffield Exports Limited

INDEX (Sheet 1)

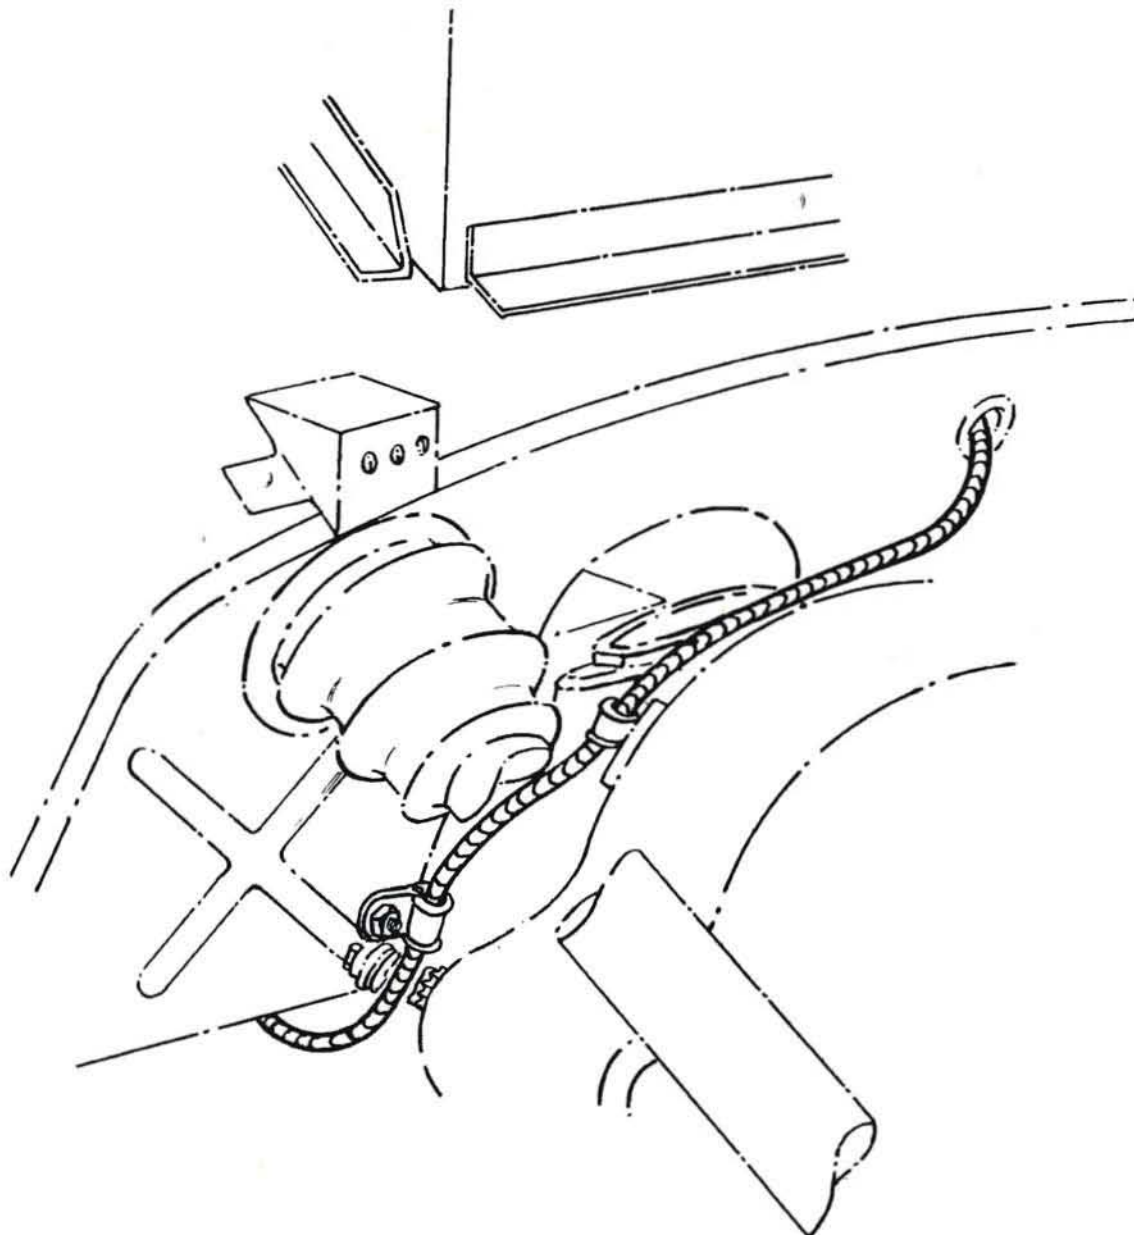
Complaints have been received of broken speedometer flexible cables, and oil finding its way up the cable and on to the numerals of the trip.

VIEW SHOWING SPEEDOMETER FLEXIBLE
CABLE RUN BETWEEN FOOT RAMP AND
CLUTCH HOUSING

To obviate this, and commencing at Chassis No. TC.2196, a new cable, Pt. No. A.1270, Jaeger No. F.245, is being fitted. Cables incorporated on chassis prior to the one quoted may be changed for the later type if desired.

The run of the cable has also been modified, and from the drive it will now pass under the gearbox in a fair radius to clear the exhaust pipe and up the off-side, being clipped to the underside of the foot-ramp, and running over the clutch housing, clipped to the clutch housing bolt, and through existing hole and grommet, as shown in sketch overleaf. The clip on the clutch housing should be twisted to maintain the curve of the flex over the housing.

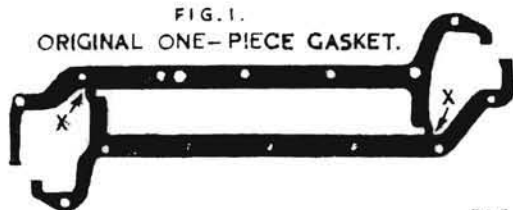
FIG. 1.
ORIGINAL ONE-PIECE GASKET.

When refitting the oil base particular care is necessary to ensure that oiltight joints are made around the front and rear crankshaft bearings.

In the first place it is necessary to take great care in cutting the gasket at the points X in Fig. 1. It is essential that the full length of the tags (shown at Y, Fig. 2) should be preserved, and that these should be cut perfectly square.

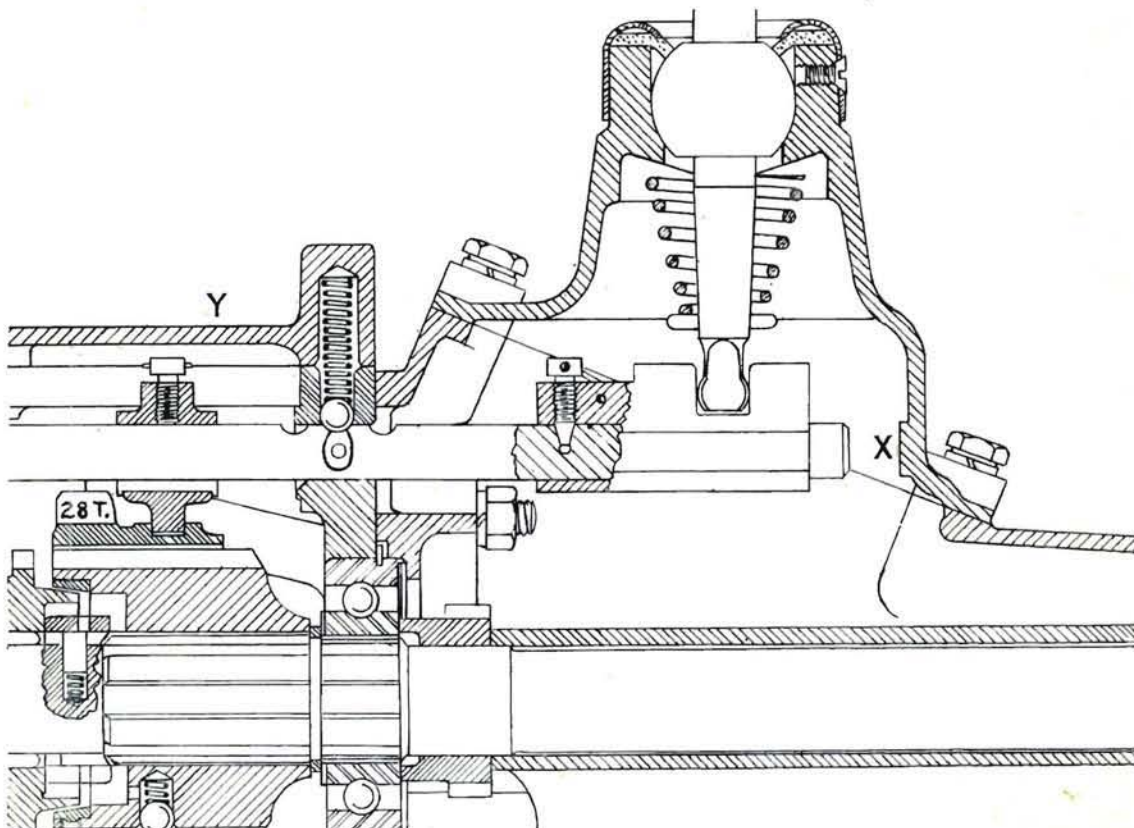
The stop for the third speed selector shaft is an abutment on the "cover for rear casing" on which the gear lever is mounted, marked X on the sketch below. Because this cover is mounted on an inclined face it is a matter of some difficulty to hold the limits for this stop, and it is possible for the third speed selector shaft to come up against its stop before the detent ball is fully seated in its groove. In these circumstances third speed will not always stay in mesh.

It is advisable to remove from the stop slightly more metal (about $\frac{1}{32}$ in.) than is necessary to permit full engagement. A condition can arise where the shaft just touches the stop in the normally engaged position and creates an annoying jangle, which is transmitted up the gear lever into the car.

The remedy is to remove metal from the stop sufficient to allow the detent ball to seat correctly.

To do this the gearbox cover (marked Y in the sketch) should be removed, together with the third speed detent ball and spring. If the gear lever is now moved as far as it will go to the third speed position it will be possible to see, by looking down the detent ball hole, by how much the shaft stops short of the fully engaged position. This indicates the amount to be removed from the stop.

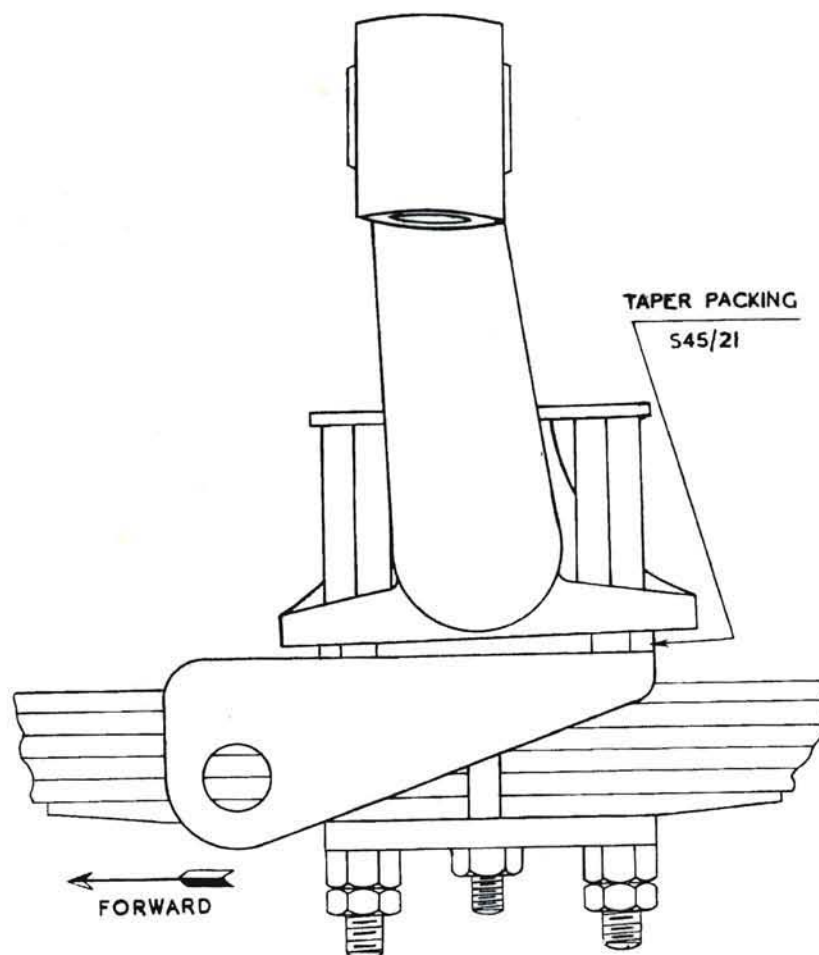
An improvement is effected by reducing the castor angle from 8° to $5\frac{1}{2}^{\circ}$.

Cars produced prior to Chassis No. TC4251 may have this modification incorporated by fitting a taper plate—Part No. S45/21.

The correct position for the taper plate to be fitted is immediately beneath the front axle pad, with the *thicker* portion at the *rear* as shown in the sketch below.

In the majority of cases the existing bolts will be found to be of sufficient length, but if not, further bolts which are $\frac{1}{4}$ in. longer may be obtained, Part No. S33/85.

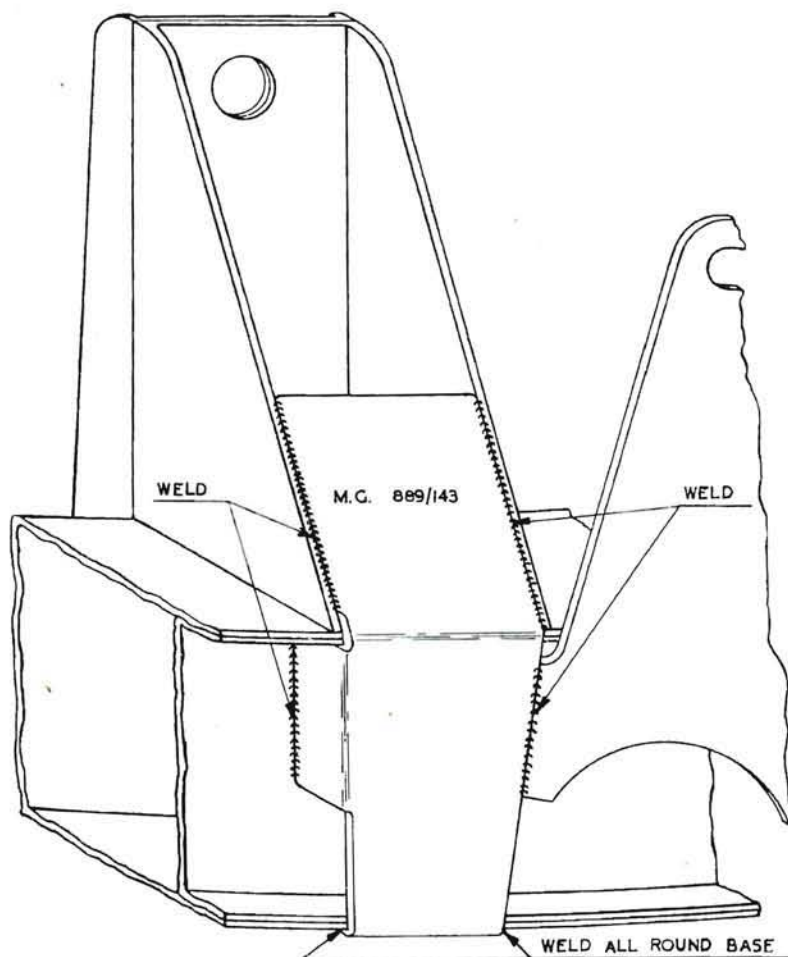
This component which is integral with the rear of the chassis frame has been reinforced on car production commencing at Chassis No. Y0541.

There is a possibility, on vehicles prior to this, that the bracket may tend to break away from the chassis frame.

If this condition arises the fractures should be repaired by gas welding, and a reinforcing plate, to Part No. MG889/143, welded on to the existing bracket.

The drawing below shows the welding seams for the attachment of the reinforcing plate.

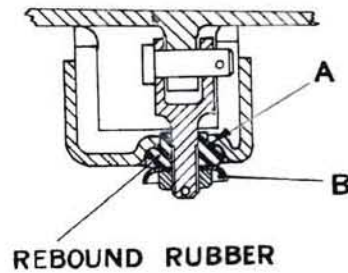
In order to prevent the rebound rubber (Part No. S75/52) from being cut by the rear engine mounting bracket, and also by the edges of the bottom washer, the hole in the bracket should be given $\frac{1}{8}$ in. radius where it is in contact with the rubber. (See A on the drawing.)

A new cup-shaped washer, Part No. S44/203, should be fitted to replace the flat one (B).

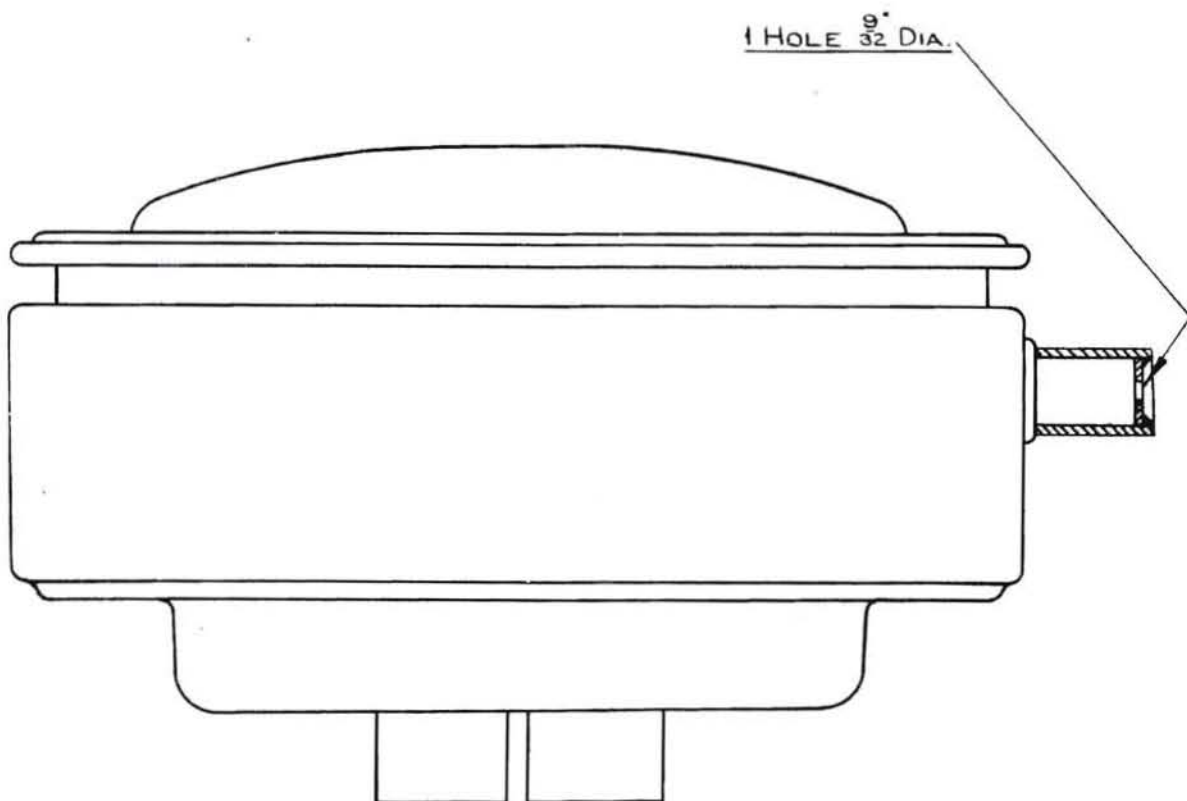
Some early cars of the "TD" Series have been observed to have a heavy oil consumption.

In some cases this has been found to be due to oil passing from the valve cover into the air cleaner and being consumed in the engine.

This can be prevented by inserting a restrictor or washer in the air cleaner engine breather pipe as indicated in the sketch below.

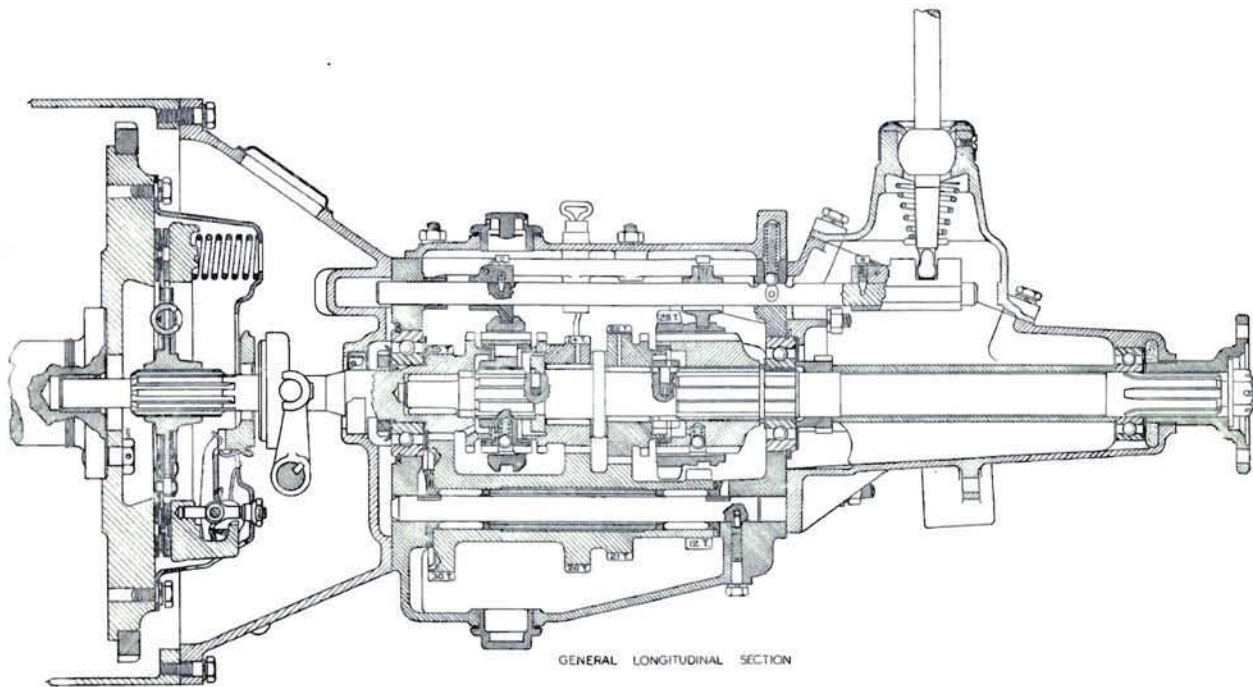
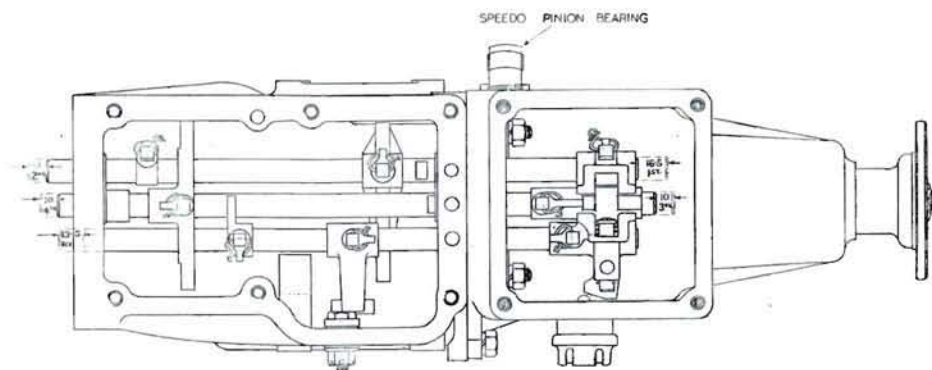
Sectional view of the gearbox

Cases have been encountered where the synchromesh hub balls have dropped out of their cage into the bottom of the gearbox, necessitating the dismantling and reassembly of the complete gearbox.

The third speed selector shaft is provided with two stops—one of the spring-loaded ball type, the other consisting of a boss on the inside face of the gear-lever housing. When the housing is removed there is no longer a rear stop to arrest the movement of the third speed selector shaft, which is liable to be withdrawn beyond its normal travel.

To obviate this, extreme care must be taken when removing and refitting the gear change lever not to withdraw the third speed gear selector shaft past the first stop, as this will cause the two components of the synchromesh mechanism to slide apart, releasing the balls and springs, which will drop into the box.

On later models a longer selector shaft is fitted which has a retaining circlip at its forward end to prevent it from being withdrawn too far.

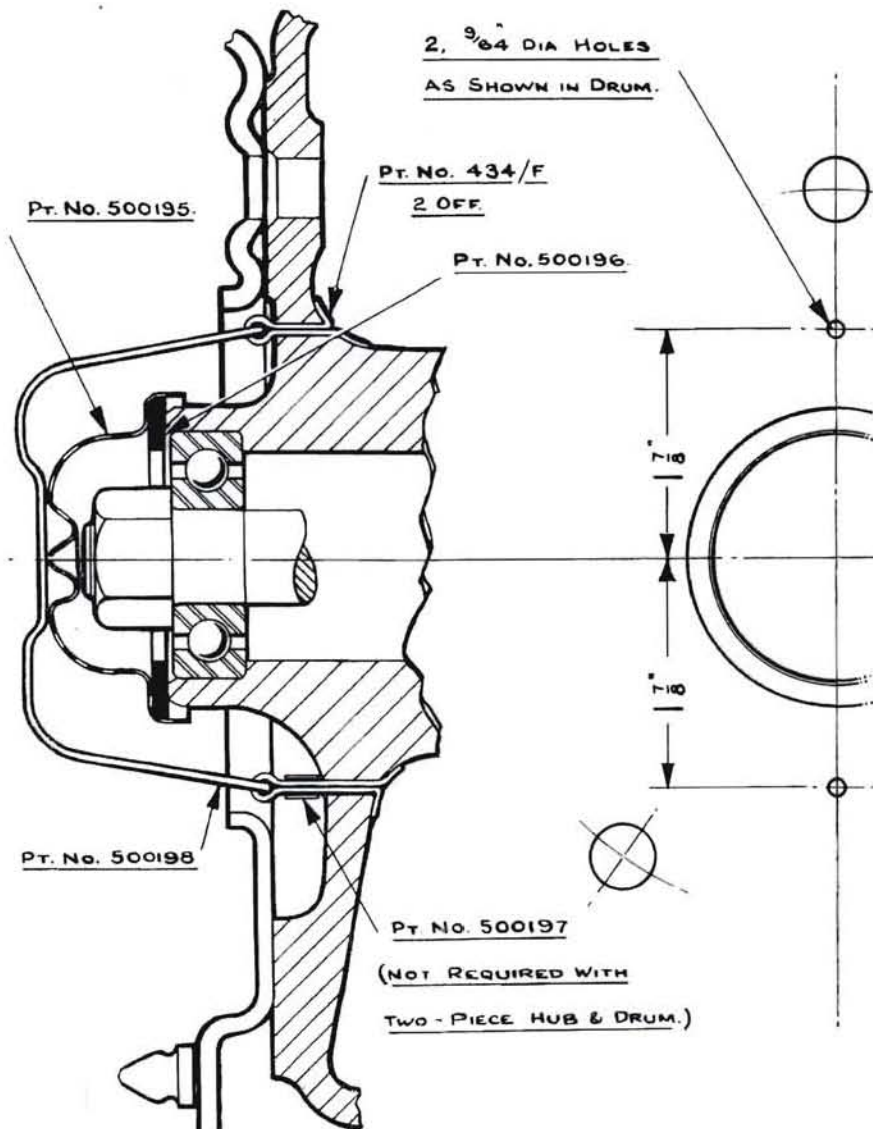
The front hubs have been subject to grease leakage from the outside felt, and production cars in future will have a grease cap fitted to the hub end, which will entail a longer hub, etc.

The Service Parts for this conversion, per car, are as follows:—

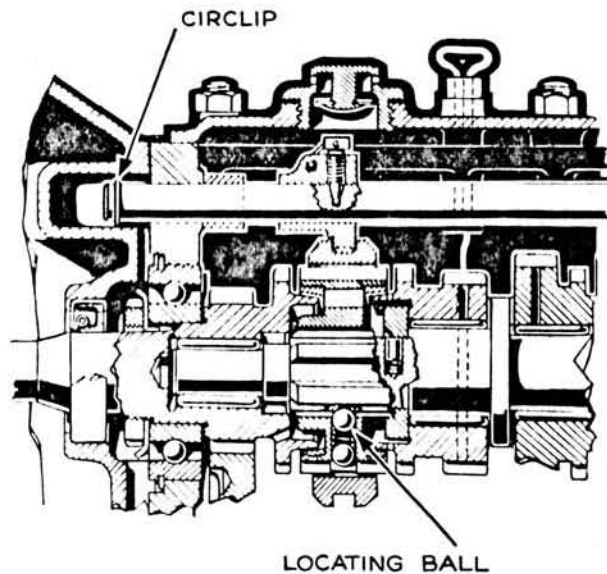
Further to S.I.S. No. 81. Cases have been found of the balls and springs being ejected from the top and third synchro hub due to discrepancies in the position of the third speed shifter shaft stop on the gear change cover. To overcome this (and also the possibility of the third gear being inadvertently moved beyond its position when the gear change extension cover is removed), a new shifter shaft is being fitted with a circlip which gives a positive stop for third gear under all conditions.

This part section of the Gearbox indicates the lengthened third speed shifter shaft and its retaining circlip and the location of the additional locating ball in the synchromesh sliding hub.

To further ensure that the synchro balls and springs do not become released, each ball is now being peened into the synchro hub (each with two square-ended depressions at the end of each ball hole around the hub); also a modified top and third striking dog, which is tapered internally each end, is now fitted to maintain the synchro-hub in the correct position.

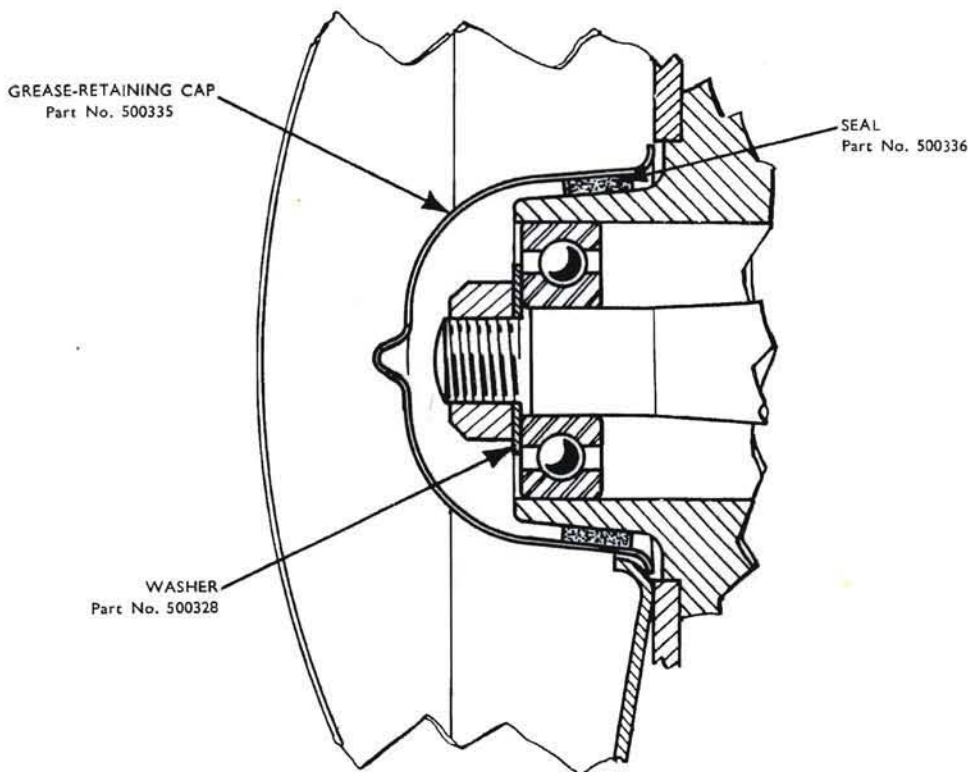
The front hubs have been subject to grease leakage from the outside felt, and a service scheme has been evolved to deal effectively with this, consisting of a grease retaining cap embracing the end of the hub and sealed by an annular felt washer.

This arrangement is clearly shown in the accompanying illustration, and it will be seen that the original oil retaining disc with its felt washer is removed from behind the hub retaining nut and replaced by the flat washer Part No. 500328.

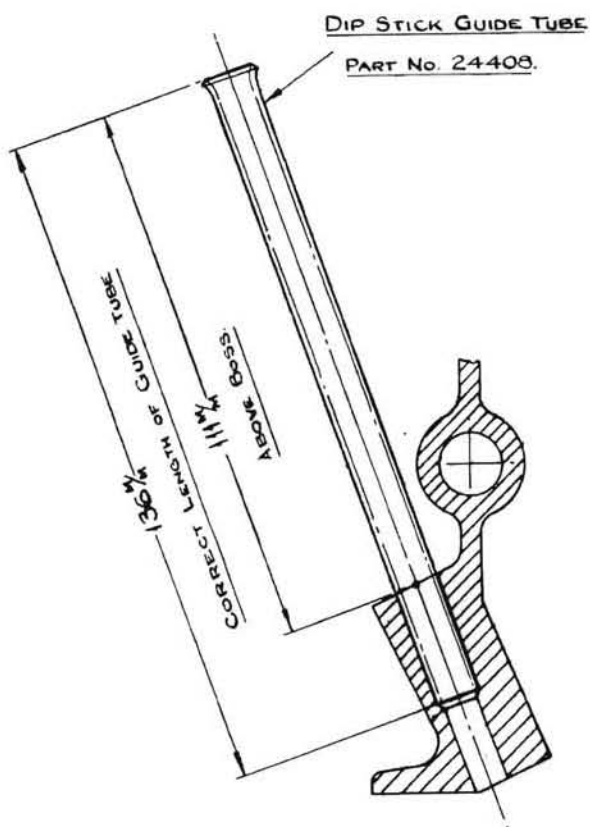
It has been found that on certain M.G. Midget (Series "TD") engines prior to Engine No. XPAG/TD10900, and on M.G. 1 $\frac{1}{4}$ litre (Series "Y") engines previous to Engine No. XPAG/SC17020, an incorrect dipstick guide tube may have been fitted, which is $\frac{1}{2}$ in. longer than the correct guide tube (Part No. 24408). This would, of course, give a false indication of the level and raise the effective oil level $\frac{1}{2}$ in. above the correct position.

In the majority of cases this will cause no harm, particularly if the level is habitually kept below the "Full" mark, but should the sump be filled above the "Full" mark there is the possibility of the crank-throws dipping in the oil and producing excessive lubrication of the cylinders, etc.

The correct length of the dipstick guide is indicated in the illustration and is easily checked.

If it is necessary to shorten the tube or fit a new one it is easily removed from the cylinder block, in which it is a press fit, by twisting it with suitable grips while pulling it out.

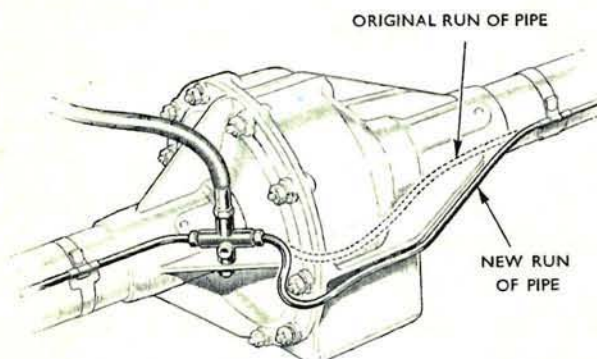
The hydraulic brake pipe connecting the rear axle hose 3-way junction with the right-hand wheel cylinder has been found to foul the front face of the side curtain stowage box on certain cars on upward movement of the axle.

This has been found to be due to the pipe having been set so that it is too far from the axle case, causing it to foul the centre of the side curtain stowage box.

If the pipe has been fouling, a mark will be evident on the front plate of the stowage box confirming this, in which case the pipe should carefully be examined for damage. Should there be any signs of wear on the pipe it must be renewed immediately, and in any case it should be refitted so as to prevent contact with the stowage box.

When refitting the pipe, release the clips locating it to the axle and bend the pipe downwards reasonably sharply at the axle centre 3-way junction so that it passes round and under the adjacent differential case nut, and run it underneath the web on the right-hand side of the axle centre case—instead of on the top of the web as originally fitted—keeping the pipe close to the axle centre casing.

Refit the pipe locating clips and if the pipe has been disconnected bleed the brakes.
