Service Information

Issued by
Nuffield Exports Limited

INDEX (Sheet 1)

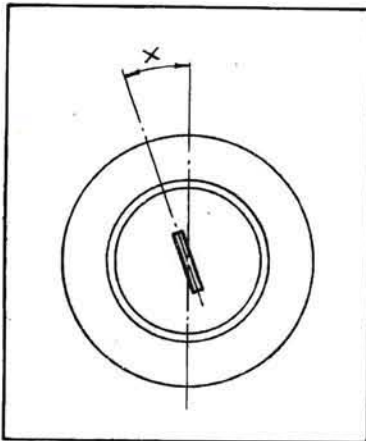
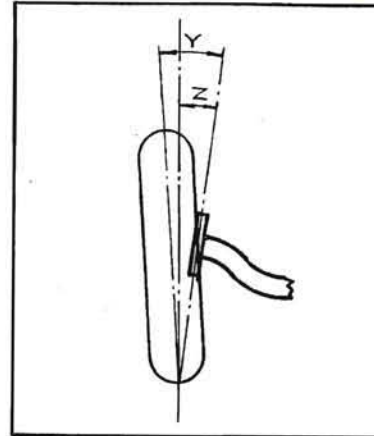
Service Information Sheet No. 61

STEERING ANGLES

B = BEAM.
P = PACKING.
S = SPRING.

The following information has been compiled to assist service stations when checking the steering gear on the various models. It is not intended for use in repairing damaged steering parts and attention is drawn to Service Information Sheet No. 10 on this subject.

Model	Castor Angle " X "	Knuckle Angle " Y "	King Pin Angle " Z "
M	3° (B Nil—P 3°—S Nil)	9°	6½°
D, J, F	6° (B 3°—P Nil—S 3°)	9°	6½°
L	7° (B 3°—P 1°—S 3°)	9°	6½°
K, KN, TA, TB	6° (B 3°—P Nil—S 3°)	10½°	7½°
P, PB	8½° (B 3°—P 2½°—S 3°)	9°	6½°
N	8° (B 3°—P 2°—S 3°)	10½°	7½°
SA	4° (B Nil—P Nil—S 4°)	10°	8°
VA	4½° (B Nil—P 1½°—S 3°)	10°	8°
WA	4° (B Nil—P Nil—S 4°)	10°	8°
TC... ..	5½° (B 3°—P 2½°—S Nil)	10½°	7½°
Y	1° ± ½°	10°	10° 11½° on full bump or rebound

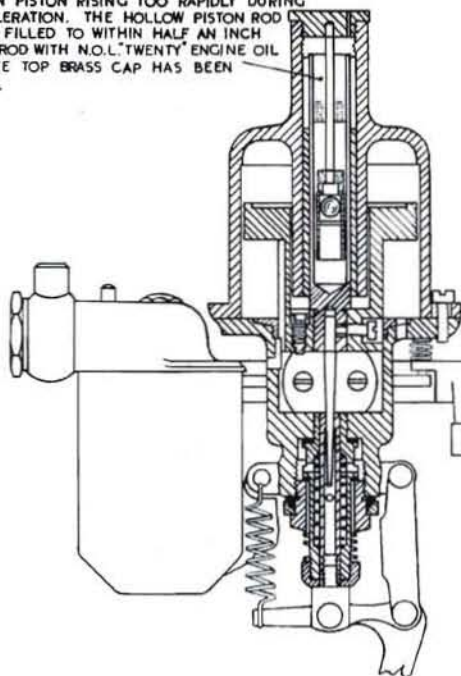
It should be noted that the hydraulic damper fitted to the TC Midget differs from that fitted to the 1½ litre. The ball valve of the former has a travel .040 in. greater than that of the latter, and this can be seen by the position of the ball retaining pin in the piston. In order to distinguish the TC damper from other dampers in stock, the TC damper is copper-plated, while the others are left with their brass finish.

A section drawing of the carburettor showing the damper is given below.

HYDRAULIC PISTON DAMPER CARBURETTORS PREVENTS THE SUCTION PISTON RISING TOO RAPIDLY DURING SNAP ACCELERATION. THE HOLLOW PISTON ROD SHOULD BE FILLED TO WITHIN HALF AN INCH OF TOP OF ROD WITH N.O.L. "TWENTY" ENGINE OIL - AFTER THE TOP BRASS CAP HAS BEEN UNSCREWED.
